REPORT NO. 3549

ERIE RAILROAD COMPANY

IN RE ACCIDENT

AT PATERSON, N. J., ON

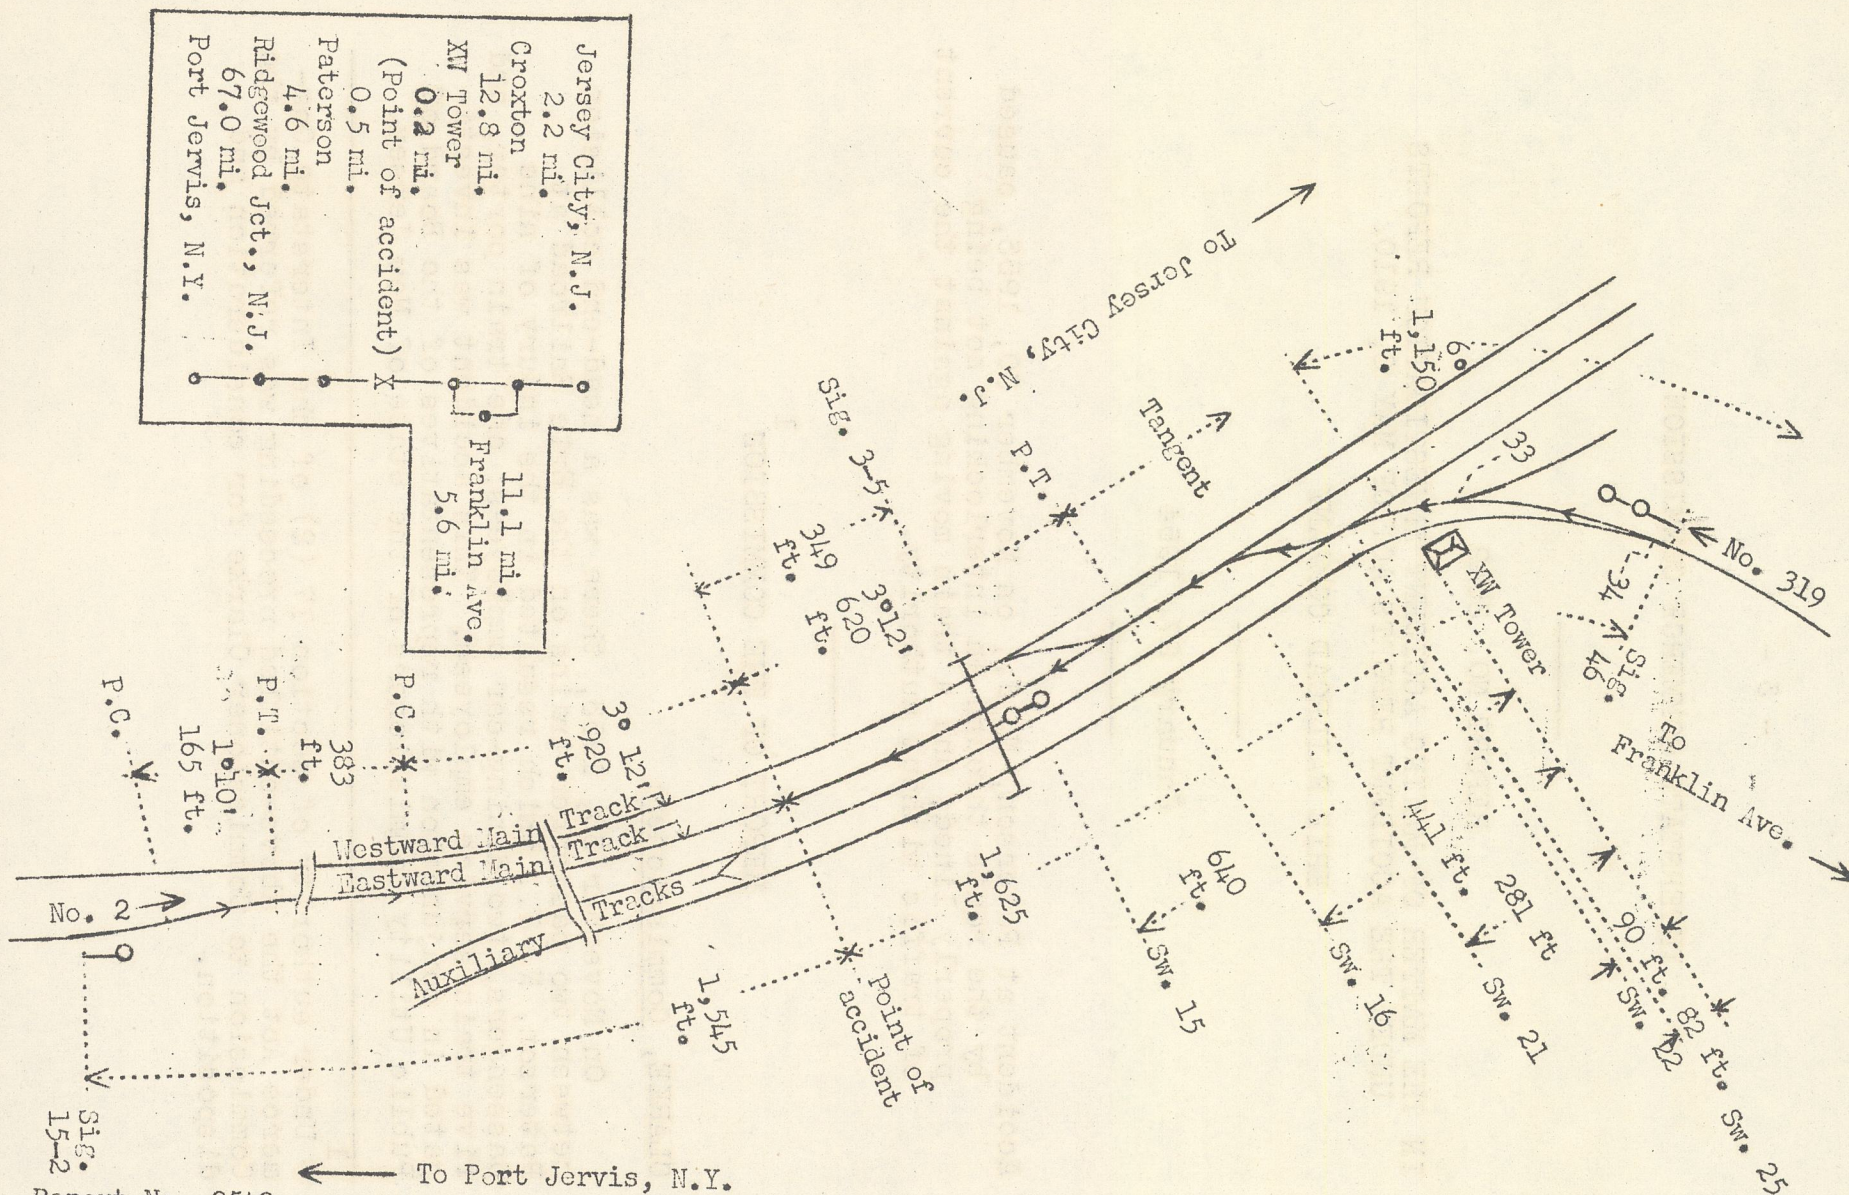
Report No. 3549
 Eric Railroad
 Paterson, N.J.
 November 30, 1953

Location of Accident and Method of Operation

Interlocking signal 46, governing west-bound movements from the Newark Branch, is located 1,625 feet east of the point of accident. Automatic signal 15-2 and interlocking signal 3-5, governing east-bound movements on the eastward main track, are located, respectively, 1,545 feet west and 349 feet east of the point of accident. These signals are

Interlocking limits at XW Tower extend from signal 46 to signal 3-5 on the eastward main track and to a point several feet west of switch 15 on the westward main track. The interlocking is of the electric type. It is provided with a 56-lever control machine. Mechanical, approach, time, route, and indication locking are provided. After a train enters the first track section of a route which has been established and for which a proceed signal indication has been displayed, route locking prevents the manipulation of any switch within the route until after the train has cleared the track section in which the switch is located. A track model board is located above the control machine. Visual indicators on this board become lighted when an approach circuit or any track section within interlocking limits is occupied.
